Salzgitter Mannesmann Forschung GmbH
Standort Duisburg

SZMF-ED-PB-2010-0090

**Hydrostatic pressure burst tests on four welded pipe components
and assemblies**

03/11/2010

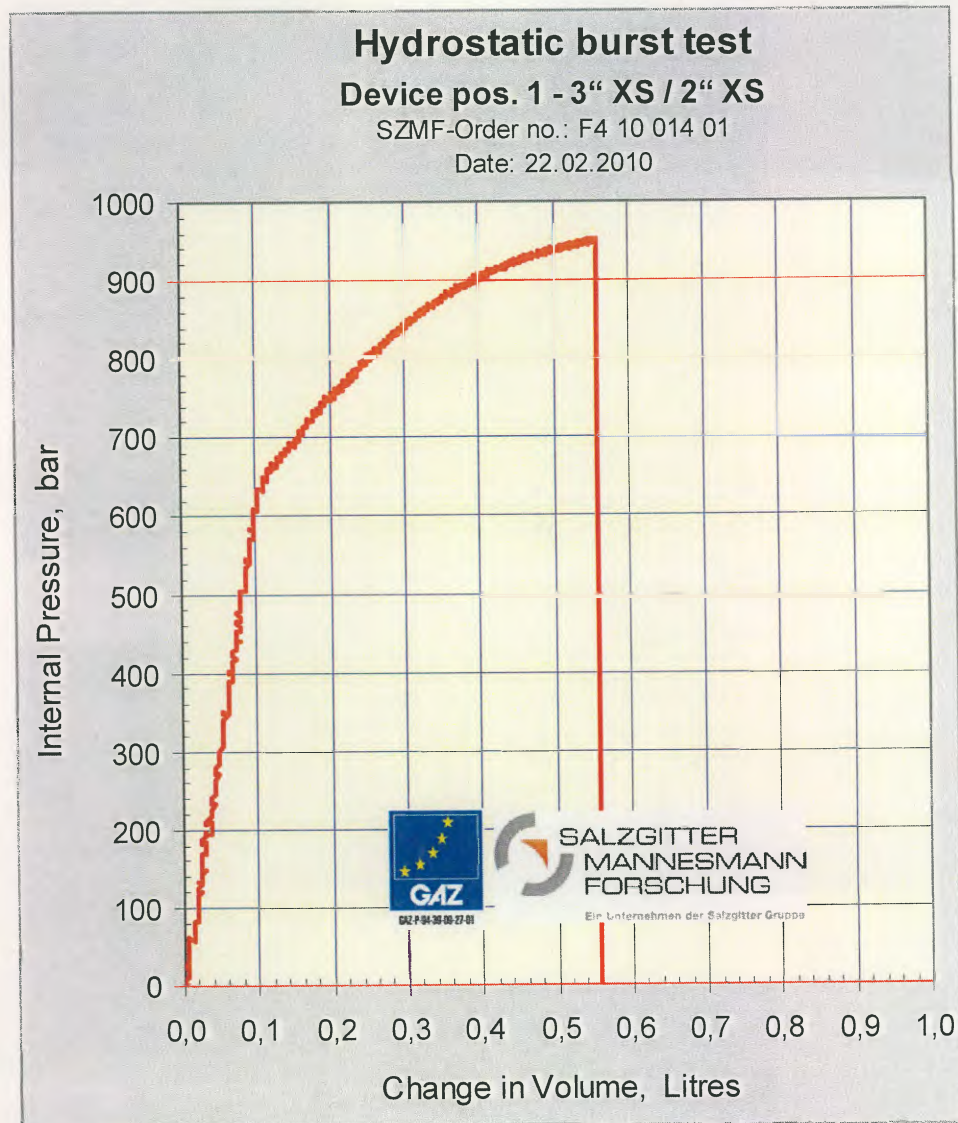
Specimen no.		3" XS / 2" XS (Figure 1)	4" XS / 3" XS (Figure 3)
SZMF – Order no.		F4 10 014 01	F4 10 014 02
Burst pressure	in bar	951,3	858,2
Volumetric increase	in litres	0,558	0,554
Location of fracture		(Figure 2)	(Figure 4)

Figure 1: Internal pressure vs. Volume diagram of burst test on specimen no. 1 – 3" XS / 2" XS

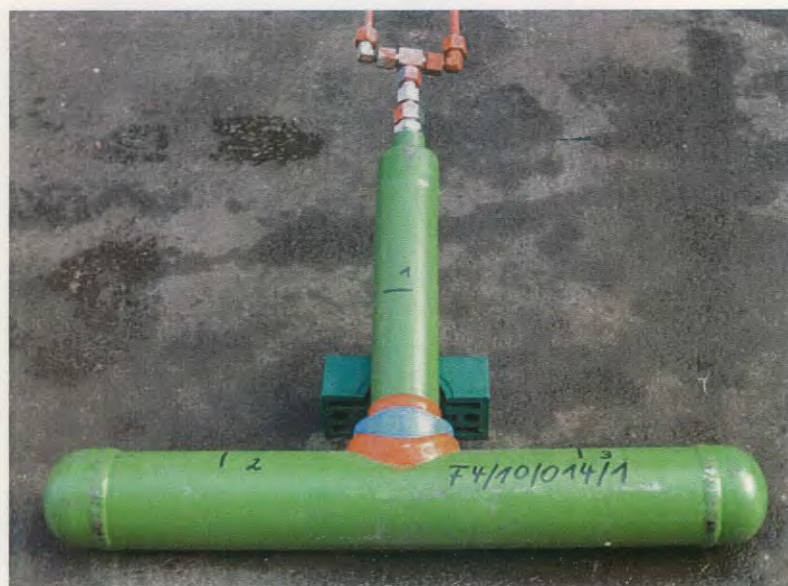
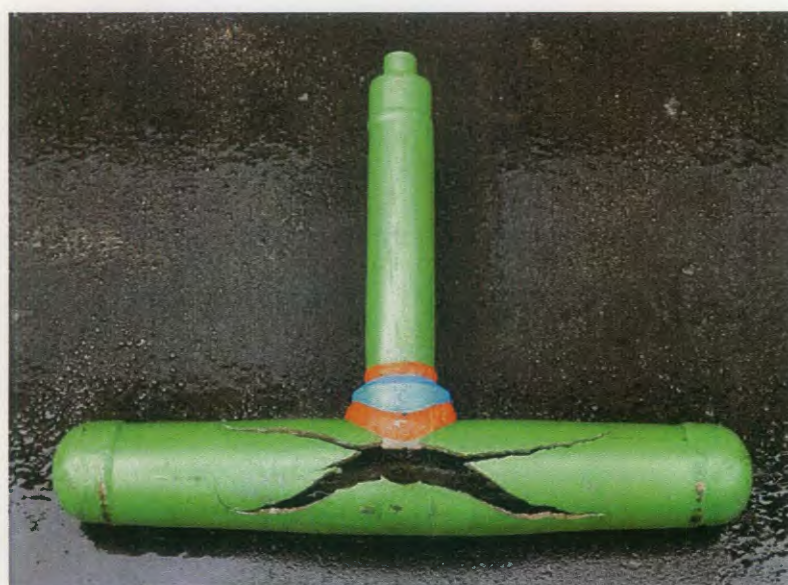
Figure 2: Specimen no.1 – 3" XS / 2" XS before and after burst test

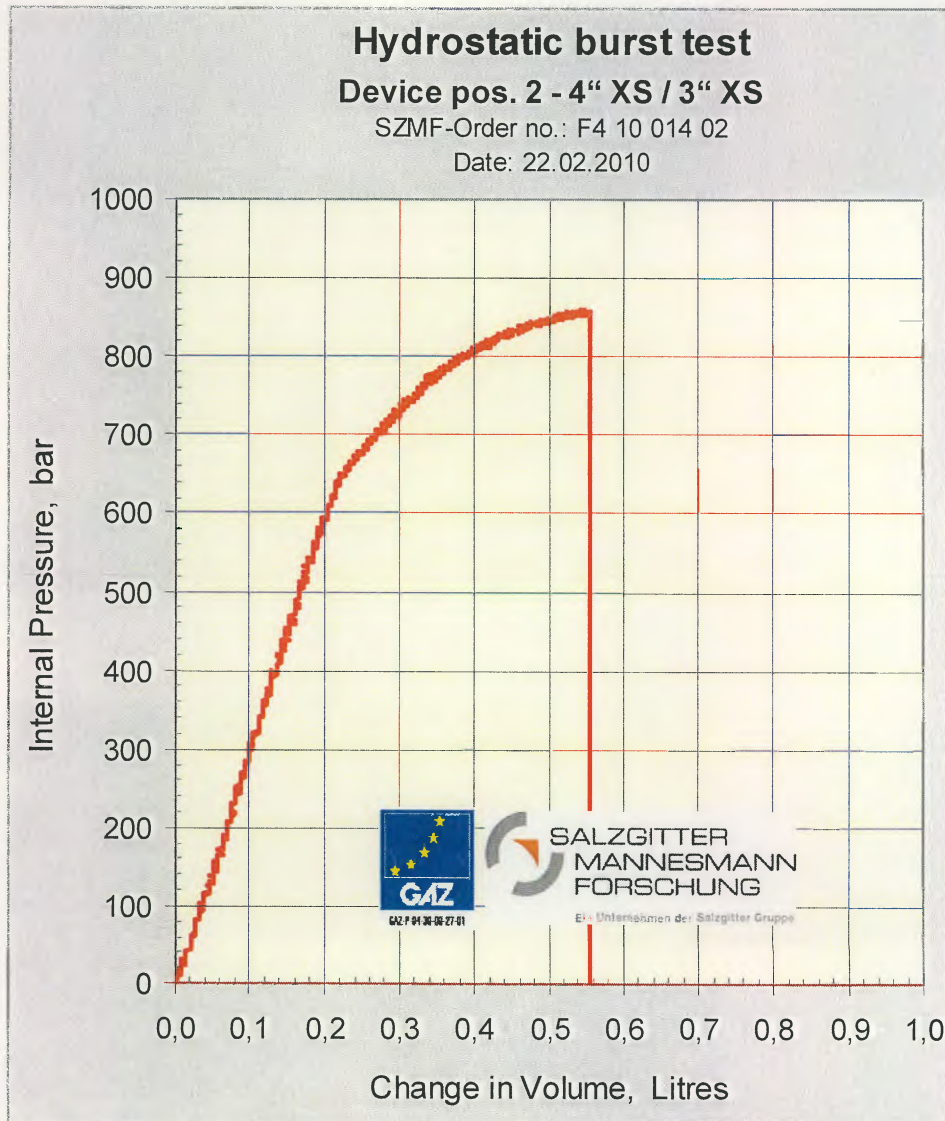
Figure 3: Internal pressure vs. Volume diagram of burst test on specimen no.2 – 4" XS / 3" XS

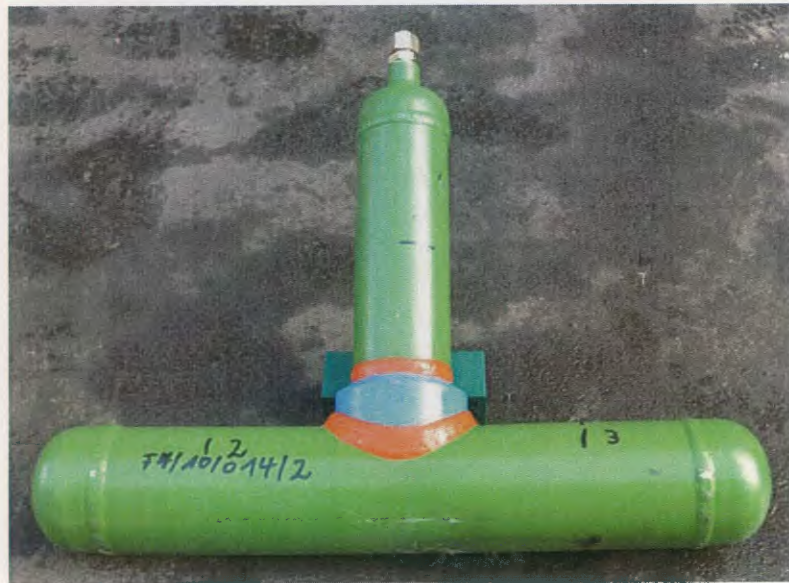
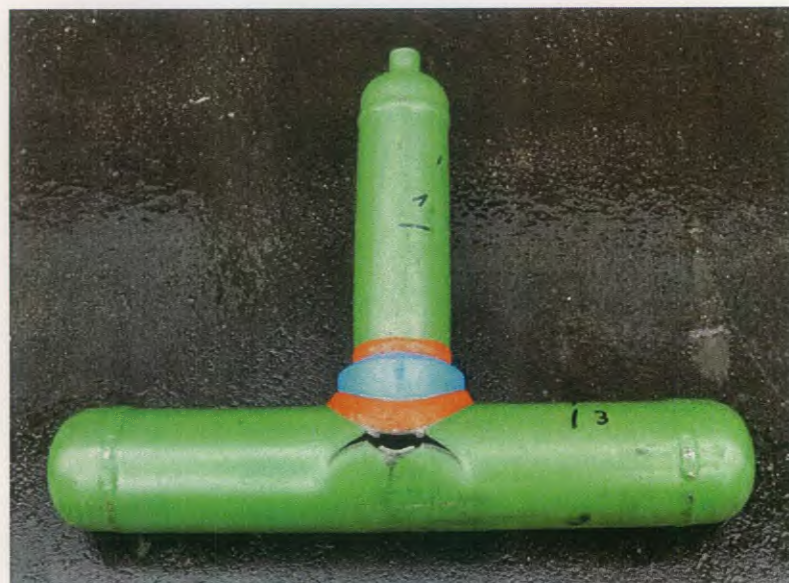
Figure 4: Specimen no.2 – 4" XS / 3" XS before and after burst test

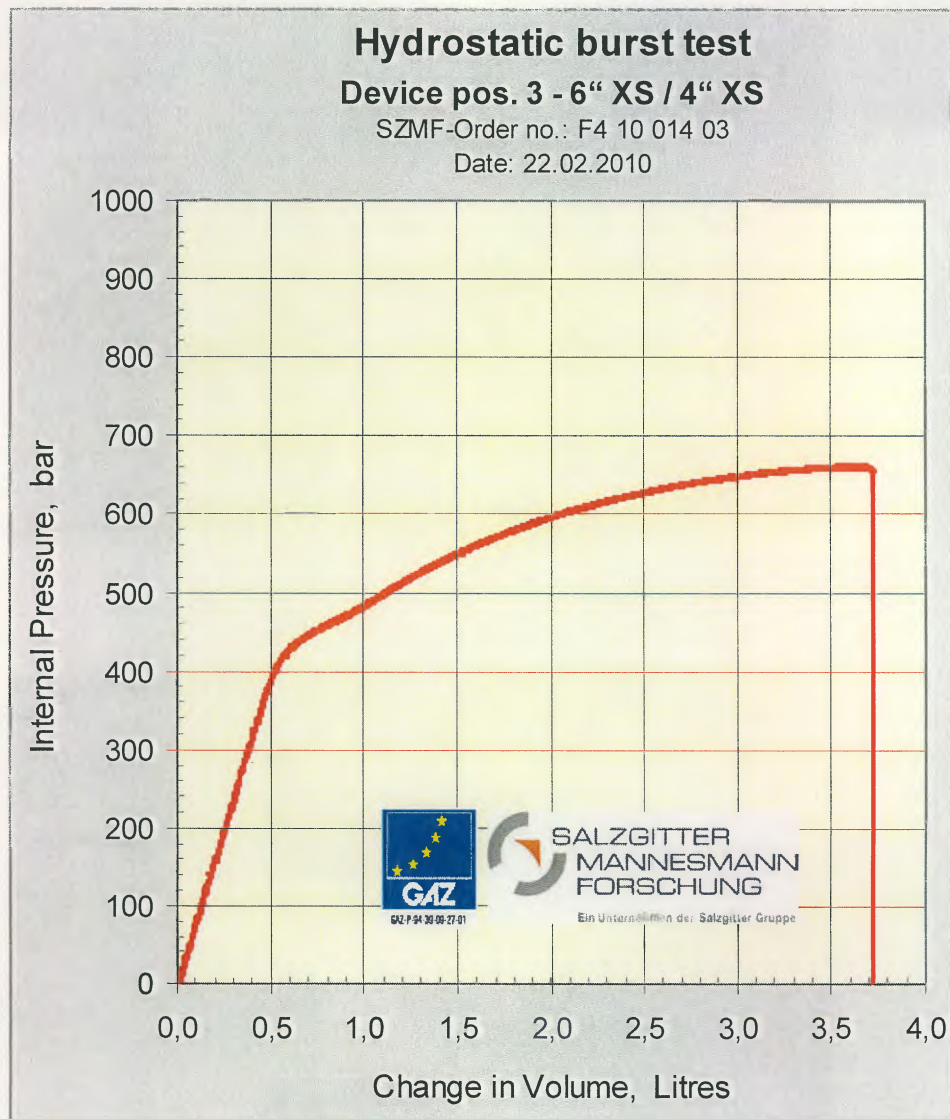
Specimen no.		6" XS / 4" XS (Figure 5)	10" XS / 6" XS (Figure 7)
SZMF – Order no.		F4 10 014 03	F4 10 014 04
Burst pressure	in bar	661,9	393,3
Volumetric increase	in litres	3,727	9,568
Location of fracture		(Figure 6)	(Figure 8)

Figure 5: Internal pressure vs. Volume diagram of burst test on specimen no.3 – 6" XS / 4" XS

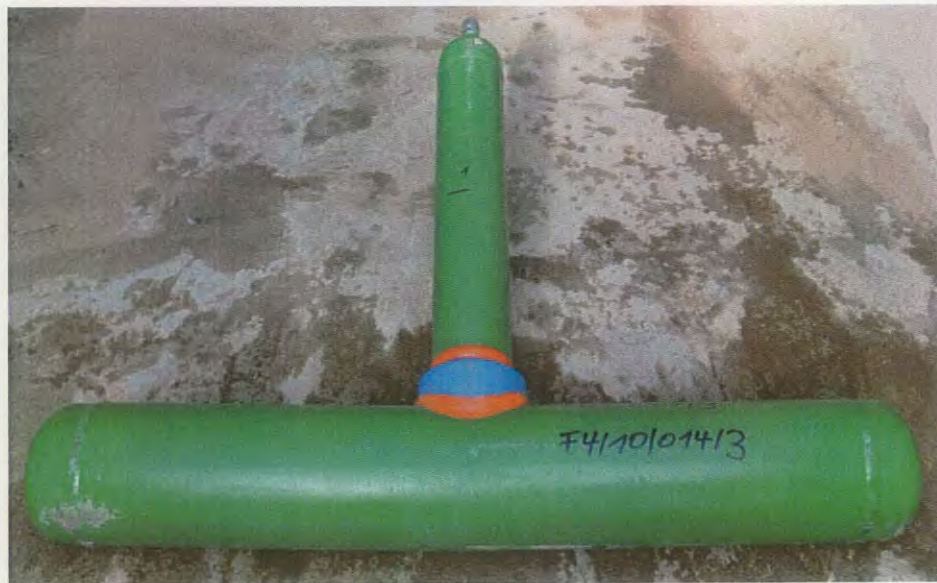
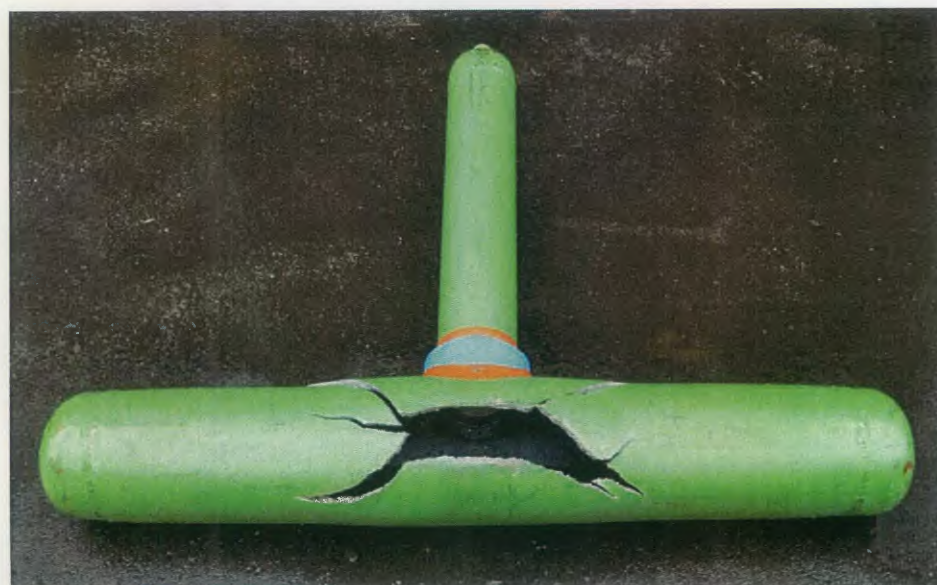
Figure 6: Specimen no.3 – 6" XS / 4" XS before and after burst test

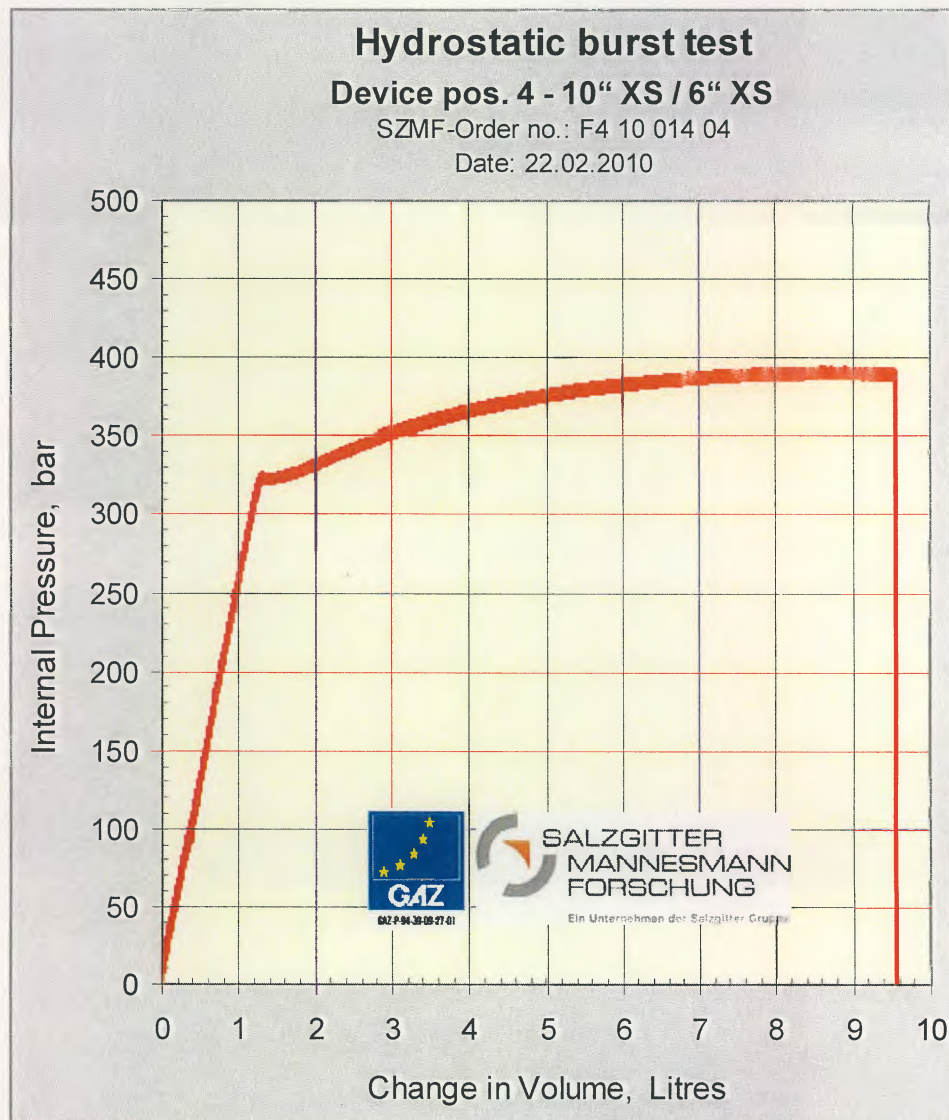
Figure 7: Internal pressure vs. Volume diagram of burst test on specimen no. 4 – 10" XS / 6" XS

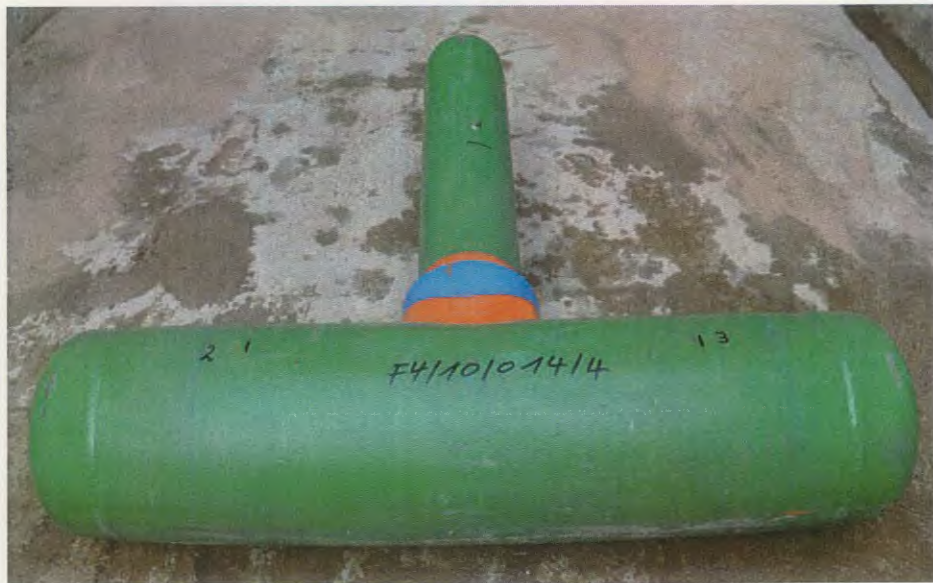
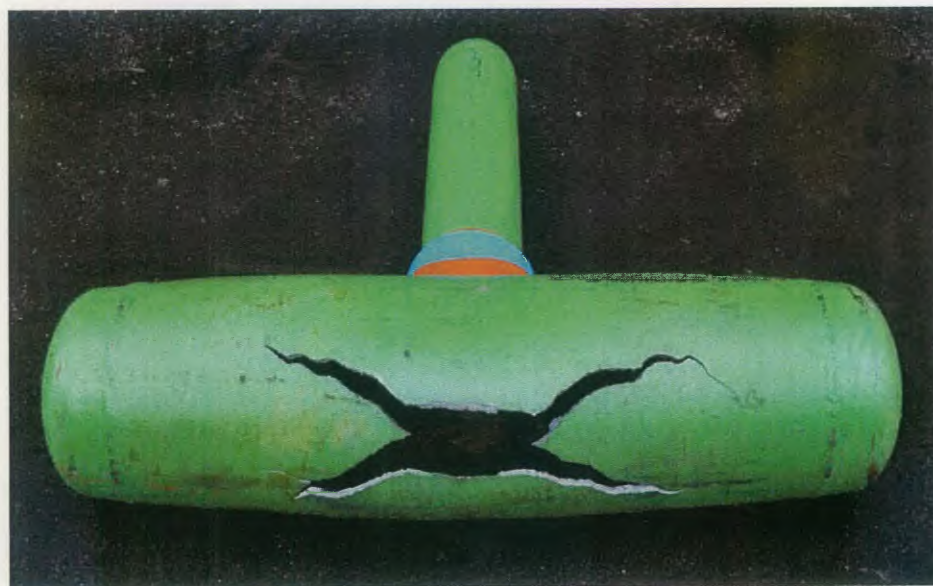
Figure 8: Specimen no. 4 – 10" XS / 6" XS before and after burst test
